## THE APPLICATION OF WELDING TO LOCOMOTIVE BOILER COPPER FIREBOXES<sup>1</sup>

J. F. HARRISON, M.I.Mech.E. (Member of Council)\*

PAPER No. 511

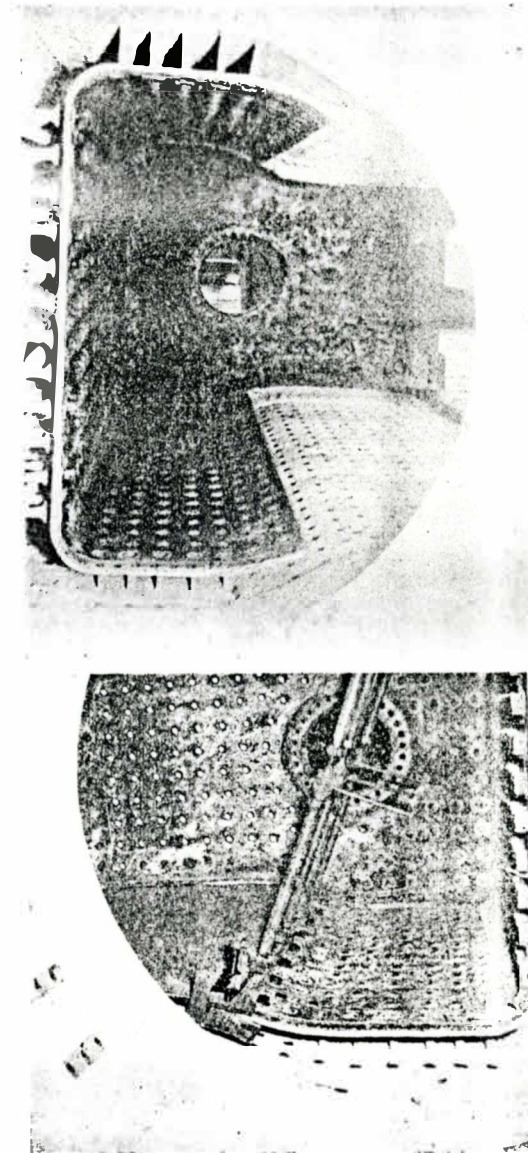
FIG. 2 (top)

The defective wrapper side is cut away (Fig. 2); the edge remaining is chipped and bevelled (a single bevel at an angle of  $30^\circ$ ), the new plate having been machined and bevelled at an angle of  $30^\circ$ , so that a resultant included angle of  $60^\circ$  is obtained, is then fitted into the firebox, secured in position by means of a steel backing strip, separated from the steel wrapper and the inner opposite copper plate by screw jacks and tubes (Fig. 3). This new plate is set to a pre-determined gap to allow for contraction, this gap being in the order of  $\frac{3}{16}$  in. per ft. run weld. The weld is carried out intermittently, followed by light hammering with a pneumatic tool, i.e. after 6 in. of welding has been completed light hammering takes place whilst the weld metal is at a high temperature, i.e. plastic. This sequence of operations proceeds until the seam is completed, following which the surplus weld metal is chipped off; the usual sequence of operations then takes place regarding marking off, drilling, tapping, etc.

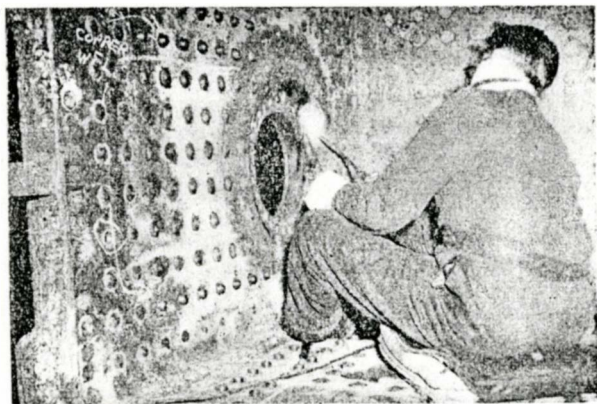
FIG. 4

OPERATOR REINFORCING RADIUS OF FIREHOLE FLANGE

Figure 4 shows an operator reinforcing the radius of a firehole flange. During the initial experiments to perfect this operation it was found that the heat applied caused such movement of the plate that the resultant contraction induced cracking, to overcome which it was found necessary to remove a number of the firehole rivets. The removal of these rivets enables the copper plate to expand freely during welding, and after welding has been completed the plate shrinks back so that the rivet holes are coincident with the steel firehole ring holes. Fig. 4 shows a right-handed operator. There are many cases, however, where left-handed operators are necessary.

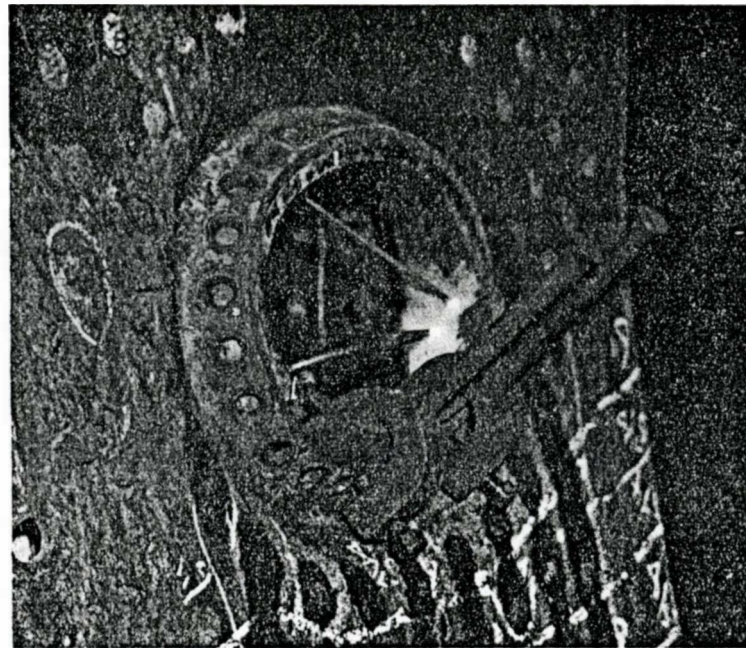
FIG. 5

WELDING OF NEW MATERIAL INTO DISHED FIREHOLE

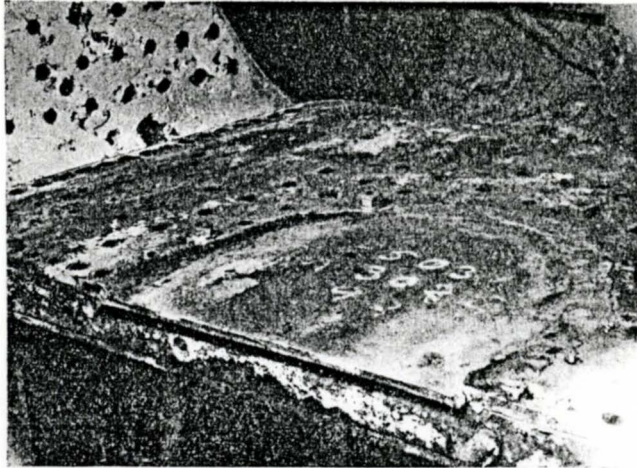
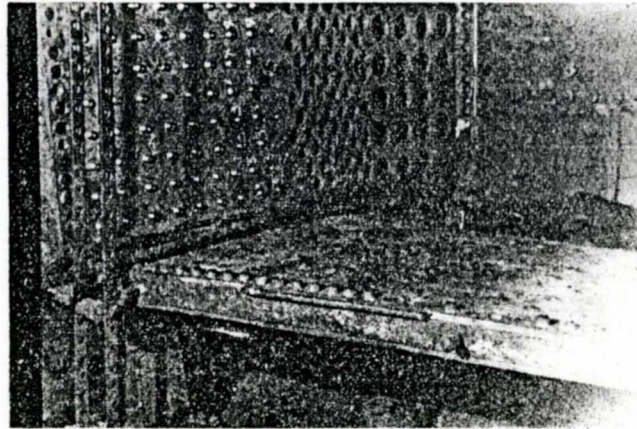
FIG. 6 (top)      FIG. 7 (bottom)  
PATCH LET INTO LOWER HALF WRAPPER SIDE

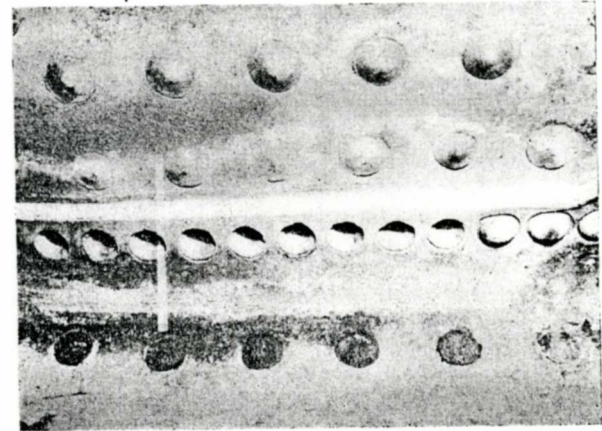
FIG. 8  
WASTED FLANGE PLATE LAP BUILT UP BY WELDING

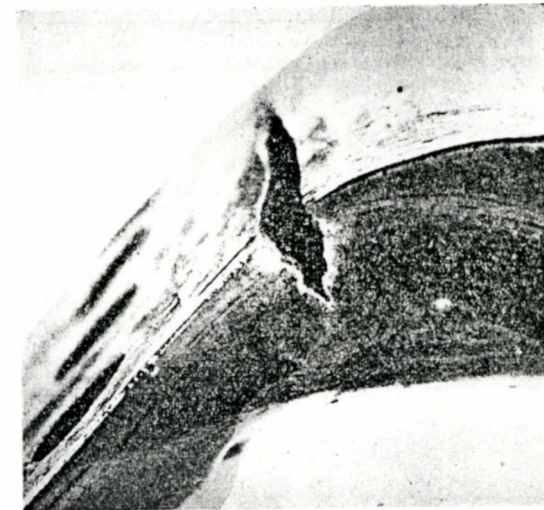
Figure 9 shows a tubeplate severely cracked on the water side and shielded at the same time by the flange. This particular type of repair necessitated welding from both sides simultaneously, having the firebox on its side and the weld made vertically.

FIG. 9  
CRACK ON WATER SIDE OF TUBEPLATE WHICH NECESSITATED WELDING FROM BOTH SIDES SIMULTANEOUSLY

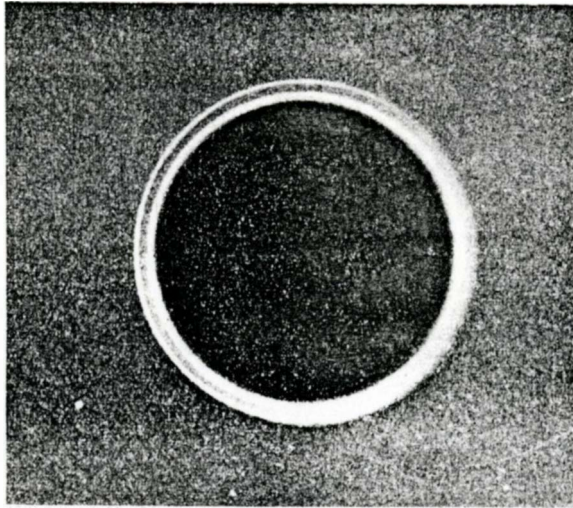
FIG. 10

Figure 10 shows a radiograph of a normal screwed stay inserted in a copper plate, the radiograph having been taken accurately through the centre of the stay. The usual tolerances (air gaps) are seen at the top and bottom of the threads, it is this gap between stay and plate which must be permanently sealed to avoid leakage.

RADIOGRAPH OF SCREWED STAY IN A COPPER PLATE SHOWING TOLERANCES (AIR GAPS) AT TOP AND BOTTOM OF THREADS

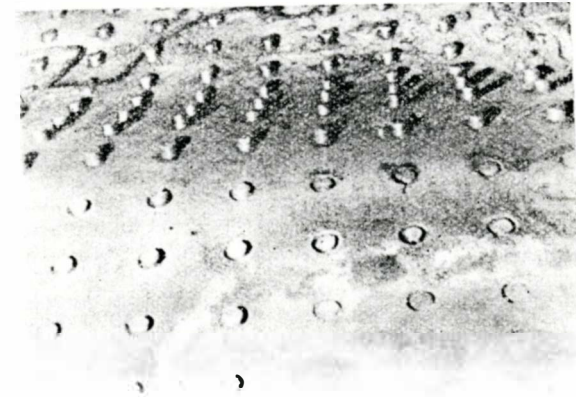
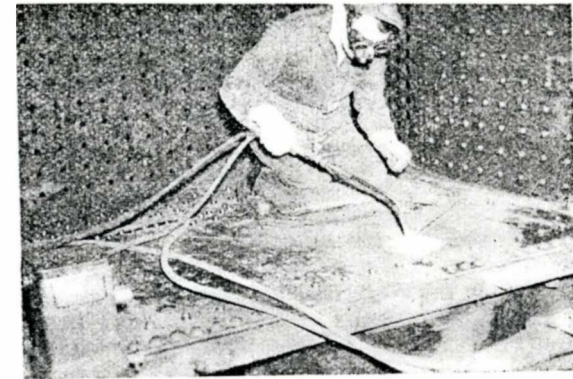
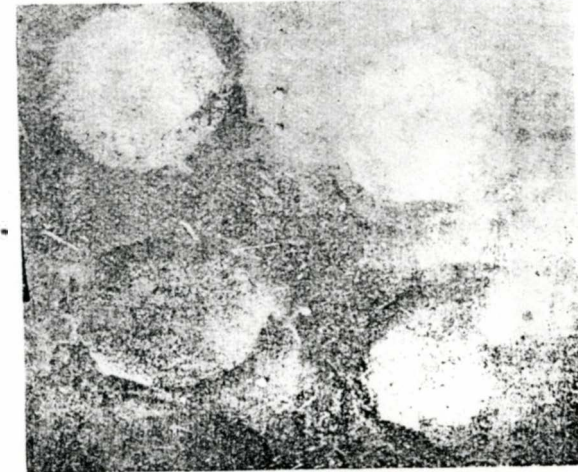
Figure 11 gives some idea of the preparation for welding. It will be seen that there is a groove around the flush stay ends. This is a deliberate countersink preparation for welding, forming a pool to collect the molten copper during the pre-heating operation. Fig. 12 shows the actual operation of stay welding and Fig. 13 shows a portion of a side plate having welded stays, from which it will be noticed that there are light identification pop marks on the firebox plate itself. These are for the purpose of picking up the centre lines of the welded stays. It will be appreciated that when these welded stays are in service it is essential to locate their position accurately, so that the normal hammer testing at motive power depots can be carried out just as easily as with the visible riveted stay. Once, therefore, the centre of the stay has been found from the pop marks, a punch is used to mark this spot. The punch is  $\frac{1}{16}$  in. diameter and is driven into the welded stay for  $\frac{1}{4}$  in.; these stay centre indication holes do not become clogged up with soot in service.

FIG. 11 (top) GROOVES ROUND STAY ENDS PREPARED FOR WELDING  
 FIG. 12 (centre) OPERATION OF STAY WELDING  
 FIG. 13 (bottom) PORTION OF A SIDE PLATE HAVING WELDED STAYS

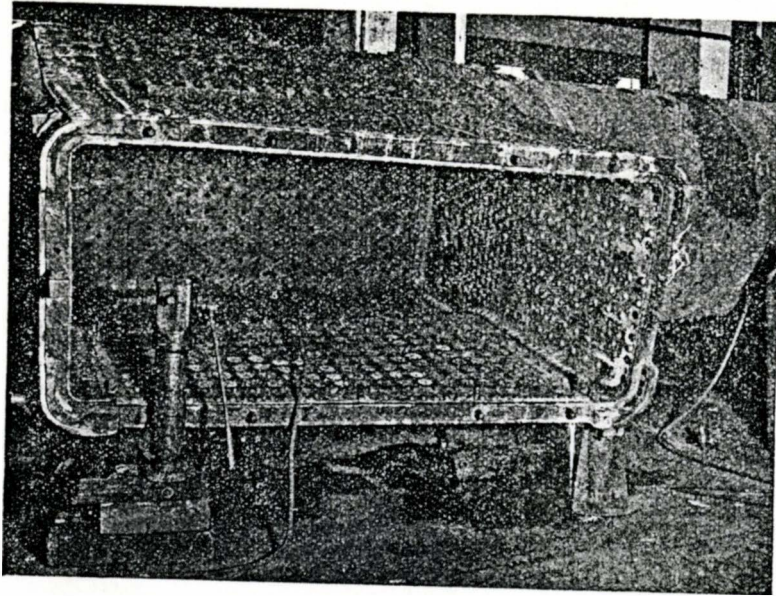
Figure 14 shows a firebox wrapper side with 155 stays welded, in a G.C. 2-8-0 0.4 class boiler. It is interesting to note that when the first firebox of this class was welded it was found that both the copper plate and the steel wrapper plate had bulged to such an extent that the foundation ring was also slightly distorted. On looking into the reason

FIG. 14  
FIREBOX WRAPPER SIDE HAVING 155 STAYS WELDED.  
G.C. 2-8-0 0.4 CLASS BOILER

for this it was originally felt that the sequence of welding the stays had some effect due to localising the heat in the centre of the plate, but experiments proved this assumption to be wrong. In practice the altered technique did not bring about the desired results, the problem being one of contraction causing distortion, this distortion being due to the very high heat input over a much increased area of firebox than the small boilers previously dealt with. The bending moment induced in the copper and steel plate being considerably increased because the supporting points, viz. the tubeplate and doorplate, were at a greater distance apart. The distortion had nothing to do with the actual welding of the copper stays, but was due to the high heat input of the acetylene method of welding.

This problem of welding the stays in long fireboxes has been successfully overcome by using running water, in the water space, as a cooling medium, the boiler being laid on its side, water being allowed to run into the water space but not of such a depth that it touches the copper plate. This was easily arranged by the introduction of a jack supporting the foundation ring which is raised and lowered according to the row of stays on which welding is being done (Fig. 14). One interesting feature of this successful method of welding copper stays in large fireboxes is that considerably more gas is used in the welding process.

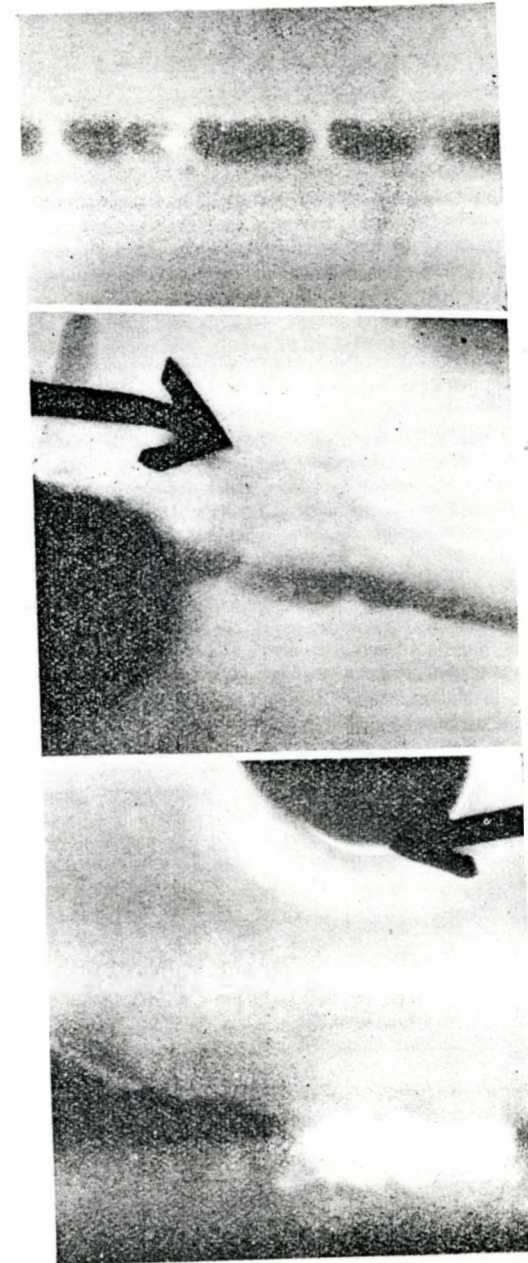
FIG. 16

X-RAY SHOWING DEFECTS IN WELDS
